December 12, 2017

CITY OF SASKATOON

Asbestos-Containing Building Materials Assessment Report - Gabriel Dumont Park Shelter Washrooms

Report Number: 1667963

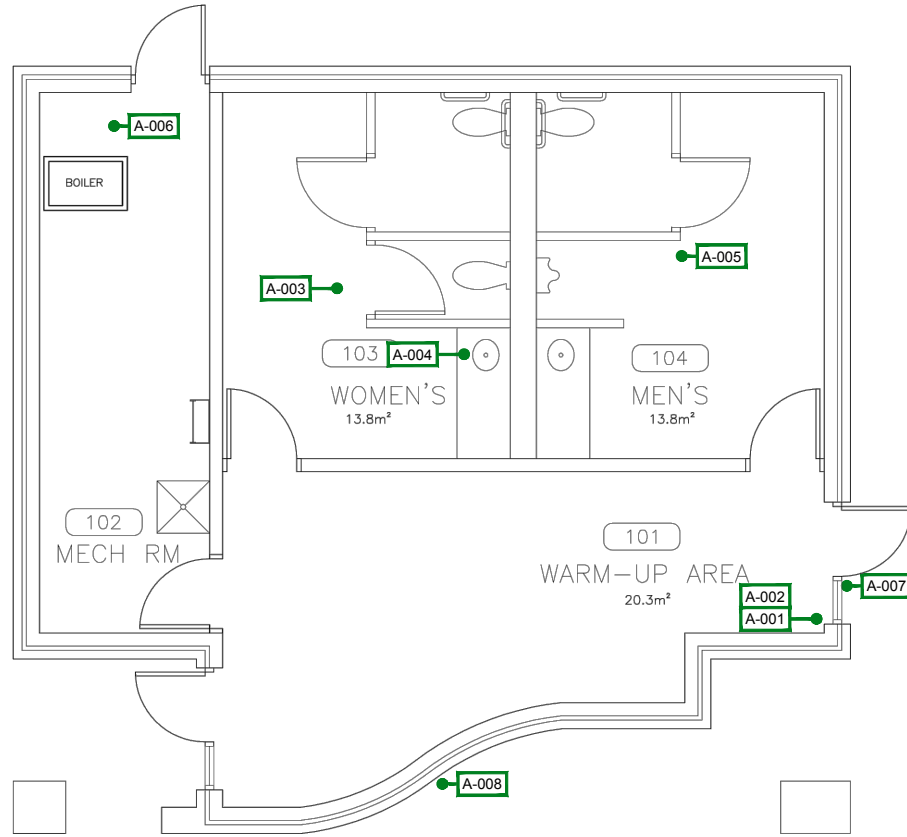
TITLE
MAIN FLOOR

NOTE(S)
 1. ASBESTOS IS A CARCINOGEN. DO NOT BREATHE ASBESTOS DUST.
 2. ASBESTOS-CONTAINING MATERIALS WERE NOT OBSERVED WITHIN THE BUILDING AT THE TIME OF THE ASSESSMENT.
