**George Ward Pool  
Asbestos Survey Report**

**February 2014**

**Prepared For: City Of Saskatoon- Infrastructure Services Department**  
1101 Avenue P North, Saskatoon, SK.  
Attn: Brent Anderson

**Prepared By: Bersch & Associates Ltd.**  
**Project No. : B67SRB11**

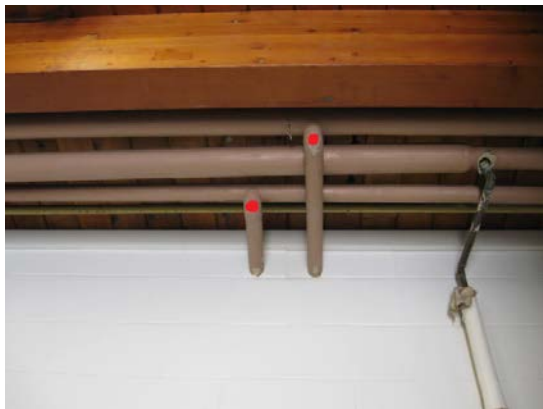
#3) Pipeline Fittings

- **Pipeline Fitting Mud Compound** is located on pipelines within rooms 107 and 109.
- **Heat Shield Material** is found within two light fixtures in 105 shower room.

NO.	DATE	SAMPLE INFORMATION	ASBESTOS	%	ANALYST
1	7-May-13	101 Mechanical Room- Boiler refractory on door	None detected		WB
2	7-May-13	101 Mechanical Room- Boiler door gasket	None detected		WB
3	7-May-13	107 Staff Room- Pipeline fitting on small brown line above sink	Chrysotile	60	WB
4	7-May-13	110 Exterior- Bulletin board adjacent entry gate	None detected		WB
5	11-Feb-14	101 Mechanical Room- Insulation on large line above boiler	None detected		WB
6	11-Feb-14	101 Mechanical Room- Boiler exhaust insulation	None detected		WB
7	11-Feb-14	101 Mechanical Room- Insulation on small line north of boiler, adjacent wall	None detected		WB
8	11-Feb-14	101 Mechanical Room- Insulation on medium line adjacent Water Heater	None detected		WB
9	11-Feb-14	101 Mechanical Room- Fire-stop material at pipe penetration into the center of the east wall	None detected		WB
10	11-Feb-14	105 Shower Room- Heat shield in light fixture	Chrysotile	60	WB

M	101	Mechanical Room	Sample	B67-ASB.8	11-Feb-14		None	Lineal Pipe Insulation			101 Mechanical Room- Insulation on medium line adjacent Water Heater	No Accessible ACM			
M	101	Mechanical Room	Sample	B67-ASB.9	11-Feb-14		None	Fire-Stop Material			101 Mechanical Room- Fire-stop material at pipe penetration into the center of the east wall	No Accessible ACM			
M	102	Chlorine Room										No Accessible ACM			
M	103	First Aid										No Accessible ACM			
M	104	Men's Washroom										No Accessible ACM			
M	105	Shower	Sample	B67-ASB.10	11-Feb-14	Chrysotile	60%	Heat Shield Material	Good	2	105 Shower Room- Heat shield in light fixture	Heat Shield Material	Moderate	Manage	Asbestos heat shields are found within the two light fixtures. Replace the globe on the one light fixture.
M	106	Women's Washroom										No Accessible ACM			
M	107	Staff Room	Sample	B67-ASB.3	07-May-13	Chrysotile	60%	Pipeline Fitting Compound	Poor	1	107 Staff Room- Pipeline fitting on small brown line above sink	Pipeline Fitting Compound	Mod/High	Remove	Remove remnants of two fittings on pipelines above the sink.
