November 3, 2017

CITY OF SASKATOON

# Asbestos-Containing Building Materials Assessment Report - Holiday Park Golf Course Greens Equipment Building

**Report Number: 1667963**

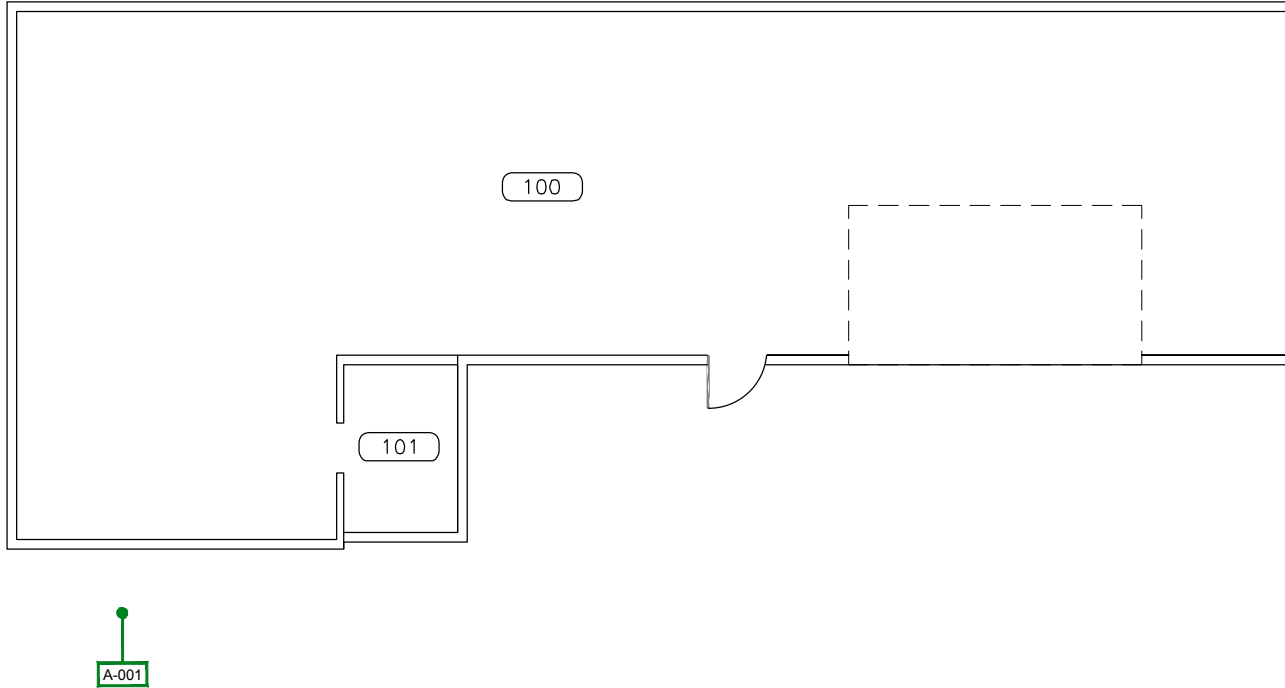
TITLE  
**GREENS EQUIPMENT BUILDING**

**NOTE(S)**  
 1. ASBESTOS IS A CARCINOGEN. DO NOT BREATHE ASBESTOS DUST.  
 2. ASBESTOS-CONTAINING MATERIALS WERE NOT OBSERVED ON SITE DURING THE ASSESSMENT.
