**J.S. Wood Library
Asbestos Survey Report**

December 2014

Prepared For: City Of Saskatoon- Infrastructure Services Department
1101 Avenue P North, Saskatoon, SK.
Attn: Brent Anderson

Prepared By: Bersch & Associates Ltd.
Project No. : B67SRL04

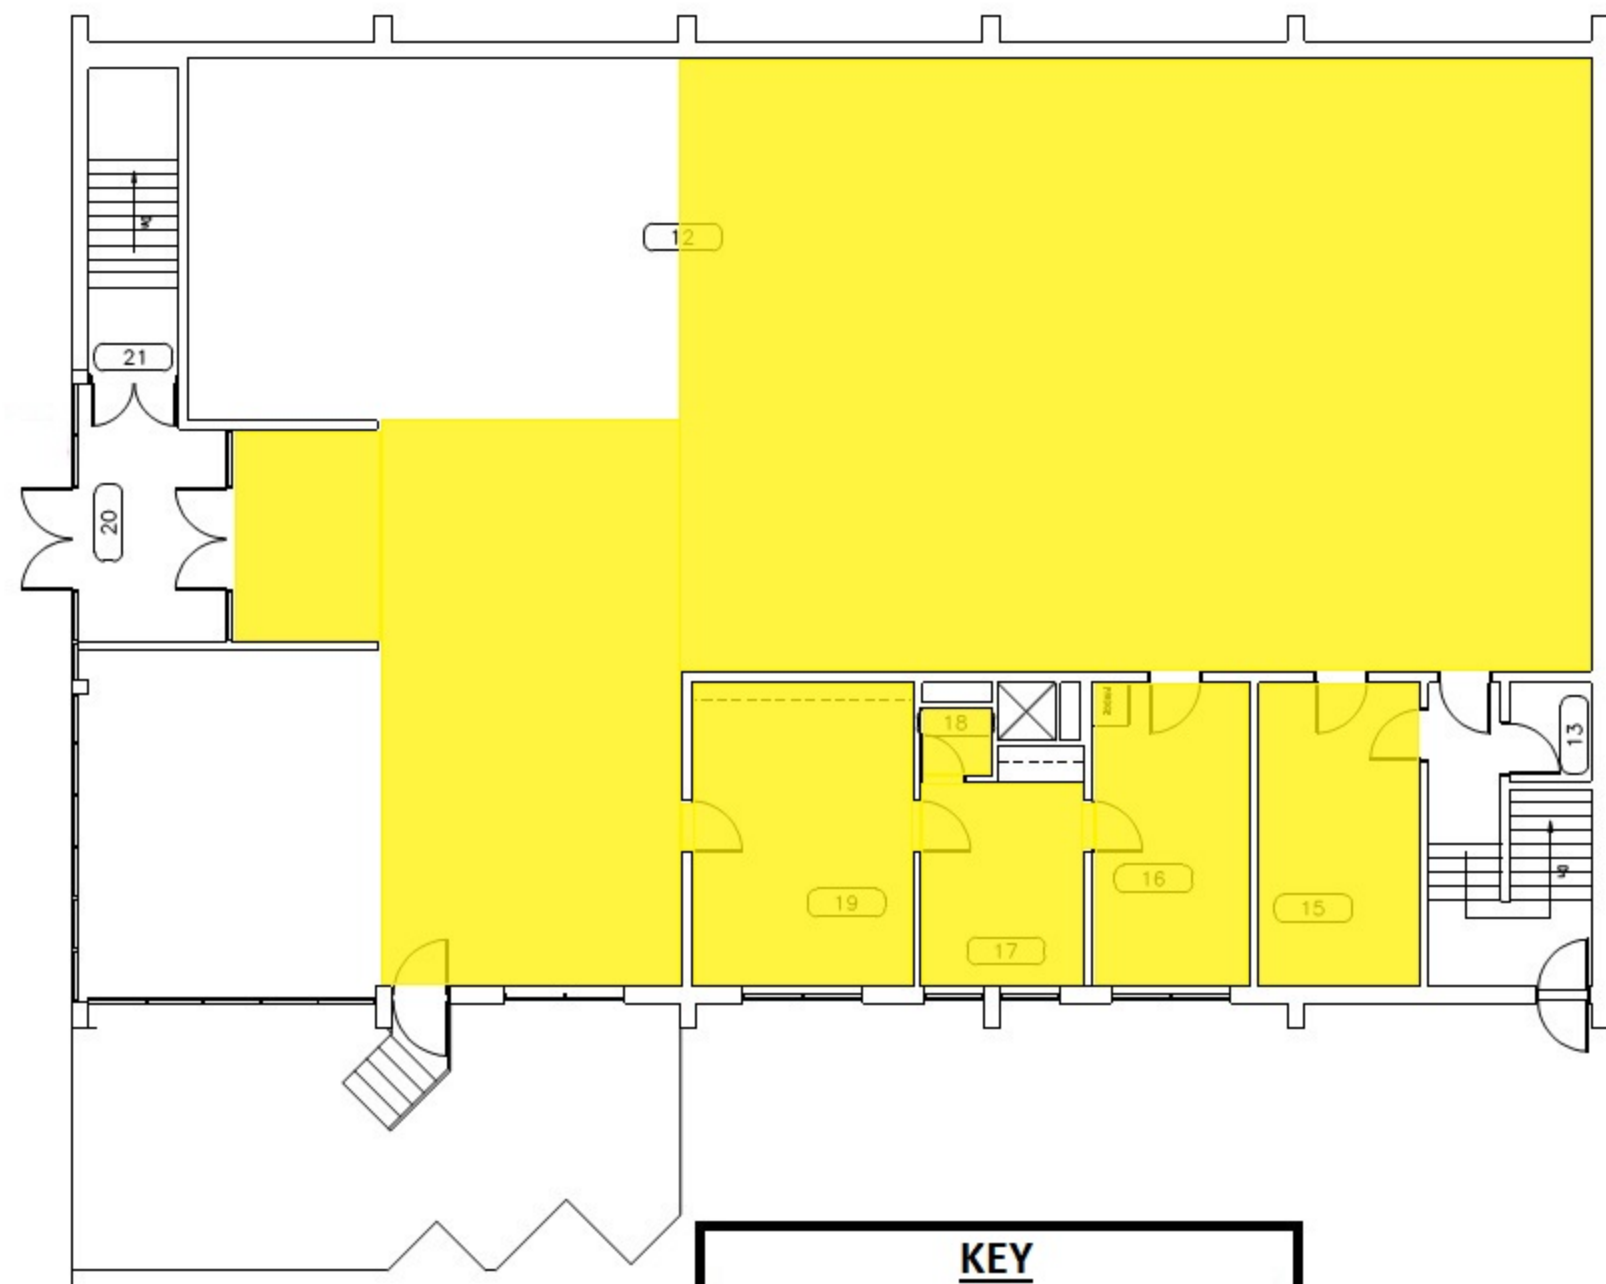
- **Vinyl Asbestos Floor Tile** is located on the Main Floor Library and Offices. The Asbestos Floor Tile is identified on the **Floor Plans** in **Appendix III** of this report.

Vinyl Asbestos Floor Tile
