## CITY OF SASKATOON

# Asbestos-Containing Building Materials Assessment Report - Nutana Lawn Bowling Storage Shed

**Report Number: 1667963**

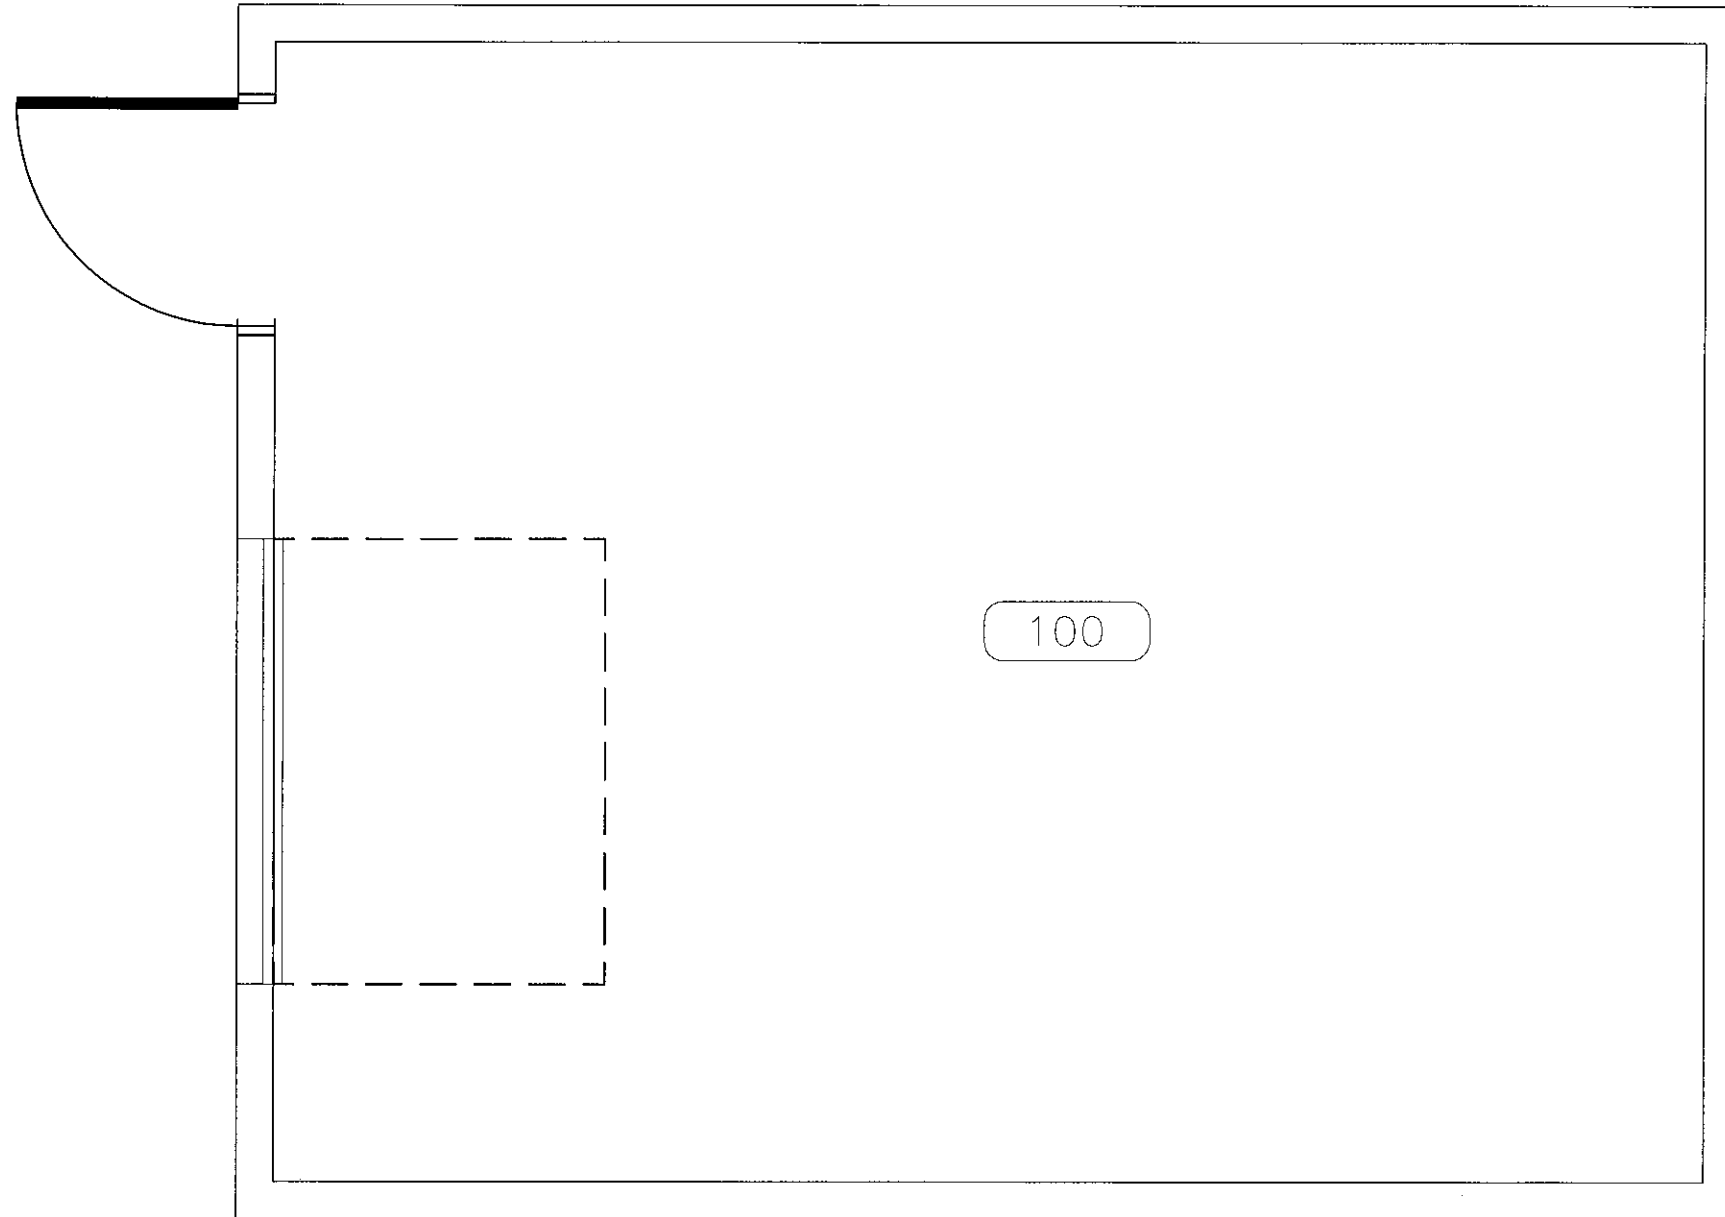
SHEET NAME  
Storage Garage  
Base Plan

Notes: 1) Asbestos is a carcinogen. Avoid breathing dust.  
2) No suspect asbestos-containing materials were observed on site during the assessment.
