Silverwood Golf Course Clubhouse

SHEET NAME	Asbuilt
Main Floor Base Plan

PROJECT TITLE
**814
Silverwood
Golf Clubhouse**

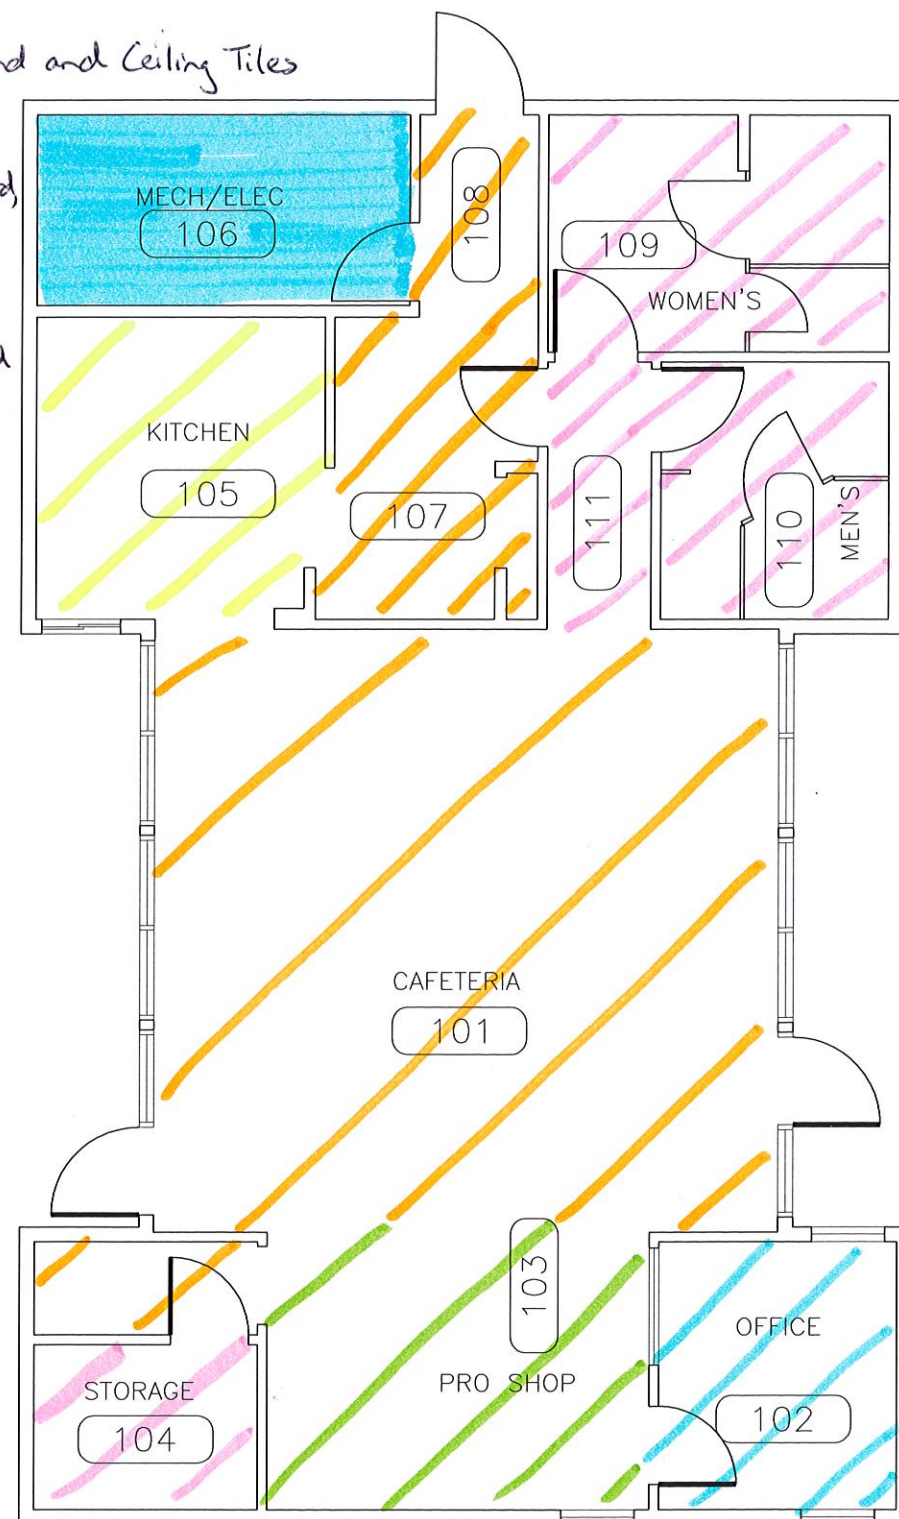
Asbestos-Containing Drywall Joint Compound

Asbestos-Containing Drywall Joint Compound and Caulking

Asbestos-Containing Drywall Joint Compound and Ceiling Tiles

Asbestos-Containing Drywall Joint Compound,
Ceiling Tiles, and Caulking

Asbestos-Containing Drywall Joint Compound
and Sink Undercoat

Asbestos-Containing Drywall Joint Compound,
Duct Mastic, Pipe-Fitting Insulation,
Caulking, and Firestop

Notes: 1) Asbestos is a carcinogen.
Avoid breathing dust.
2) Asbestos-containing caulking
and firestop are located
on the building exterior.
