February 5, 2018

CITY OF SASKATOON

# Asbestos-Containing Building Materials Assessment Report - Trailer 711

**Report Number: 1667963**

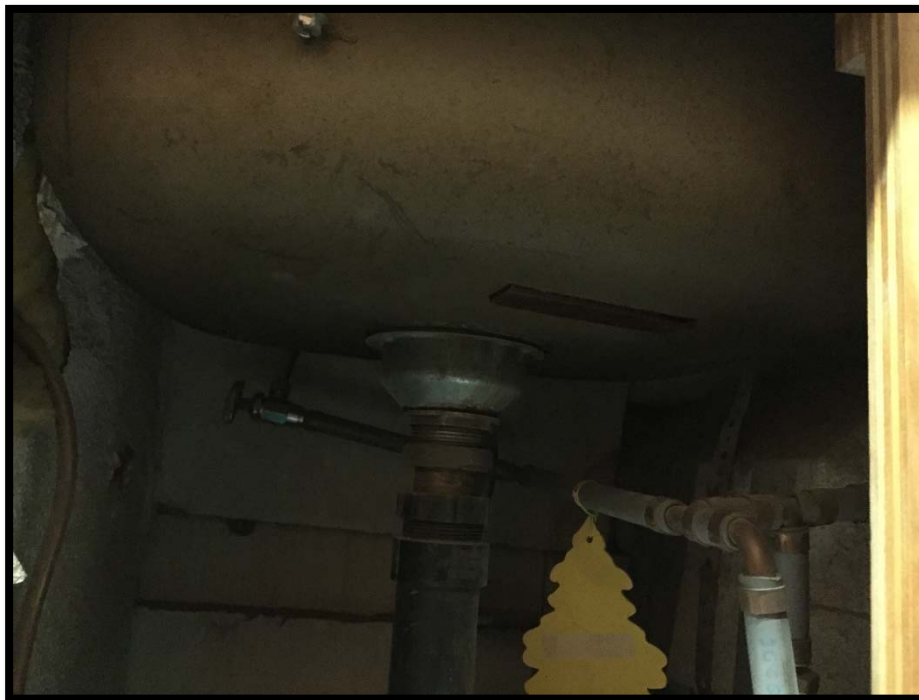
One (1) sample of gold sink undercoat was collected during the assessment. The sample collected was found to contain 3.2% Chrysotile asbestos. Asbestos-containing gold sink undercoat (see Photograph 1 in Appendix B) was observed in the following location:

- Room 100 (approximately 1 sink).

<b>Lab No.:</b> 6427302 <b>Client No.:</b> A-002 <u>Percent Asbestos:</u> <i>PC 3.2 Chrysotile</i>	<b>Analyst Observation:</b> Black Mastic <b>Client Description:</b> Gold Sink Undercoating <u>Percent Non-Asbestos Fibrous Material:</u> 5 Cellulose	<b>Location:</b> Room 100 <b>Facility:</b> <u>Percent Non-Fibrous Material:</u> 91.8
---	---	---

**Photograph 1: Asbestos-Containing Gold Sink Undercoat.**

If scheduled for impact, sinks with asbestos-containing gold undercoat should be abated following low-risk abatement work procedures as outlined in the *Saskatchewan Asbestos Abatement Manual (2017)*. Alternatively, as the gold sink undercoat was observed in good condition, and with a priority rating of 5 (please see the room by room spreadsheet provided in Appendix C for a description of the priority ratings), it can be managed in place if not scheduled for impact.
