**P. MACHIBRODA  
ENGINEERING  
LTD.**

November 3, 1998

**RE: WATER INFILTRATION  
CITY OF SASKATOON  
TRANSIT TERMINAL  
301 - 24<sup>TH</sup> STREET NW  
SASKATOON, SASKATCHEWAN  
PMEL FILE NO. S98-3169**

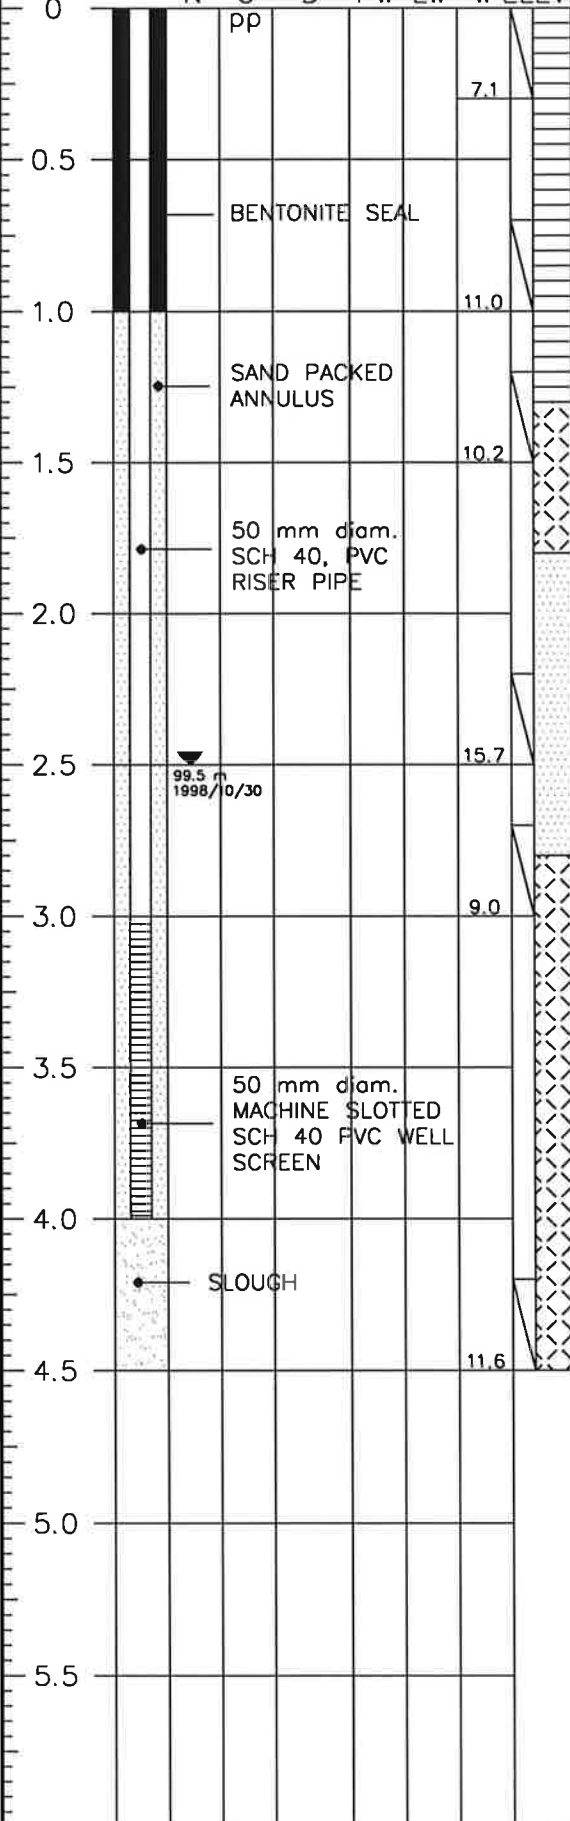
**DRAWING NUMBER:**  
S98-3169-2

Clay fill was encountered at the surface of Test Hole No. 98-1. Glacial till was encountered below the clay fill and extended to a depth of 1.8 metres below ground surface. The upper till was followed by a wet sand layer in the zone 1.8 and 2.8 metres below ground surface. The intertill sand stratum was underlain by glacial till which extended to a depth of at least 4.5 metres, the maximum depth drilled. In Test Hole No. 98-2, the 125 mm thick floor slab was underlain by sand fill overlying glacial till. As a result of encountering cobblestones in the glacial till, the Test Hole was terminated at a depth of 750 mm.

Groundwater seepage and sloughing conditions were encountered in Test Hole No. 98-1 during test drilling. The depth at which groundwater seepage and sloughing conditions were encountered have been shown on the Field Drill Log, Drawing No. S98-3169-2.

**FILL-** Clay, silty, some sand, some organics, trace gravel, moist, olive to black in intervals.

**GLACIAL TILL-** Clay, silty, some sand, trace gravel, firm to stiff, low plastic, moist, olive, oxide stained, gypsum crystals.

**SAND,** silty, dense to medium dense, poorly graded, fine to medium grained, wet, oxide stained, sloughing.

**GLACIAL TILL-** Clay, silty, some sand, trace gravel, stiff to hard, highly plastic, moist, grey, unoxidized.  
-seepage at 3.0 m.

**NOTE:**  
1. Test Hole sloughed to 3.5 m immediately after drilling.  
2. Water level 2.7 m immediately after drilling.

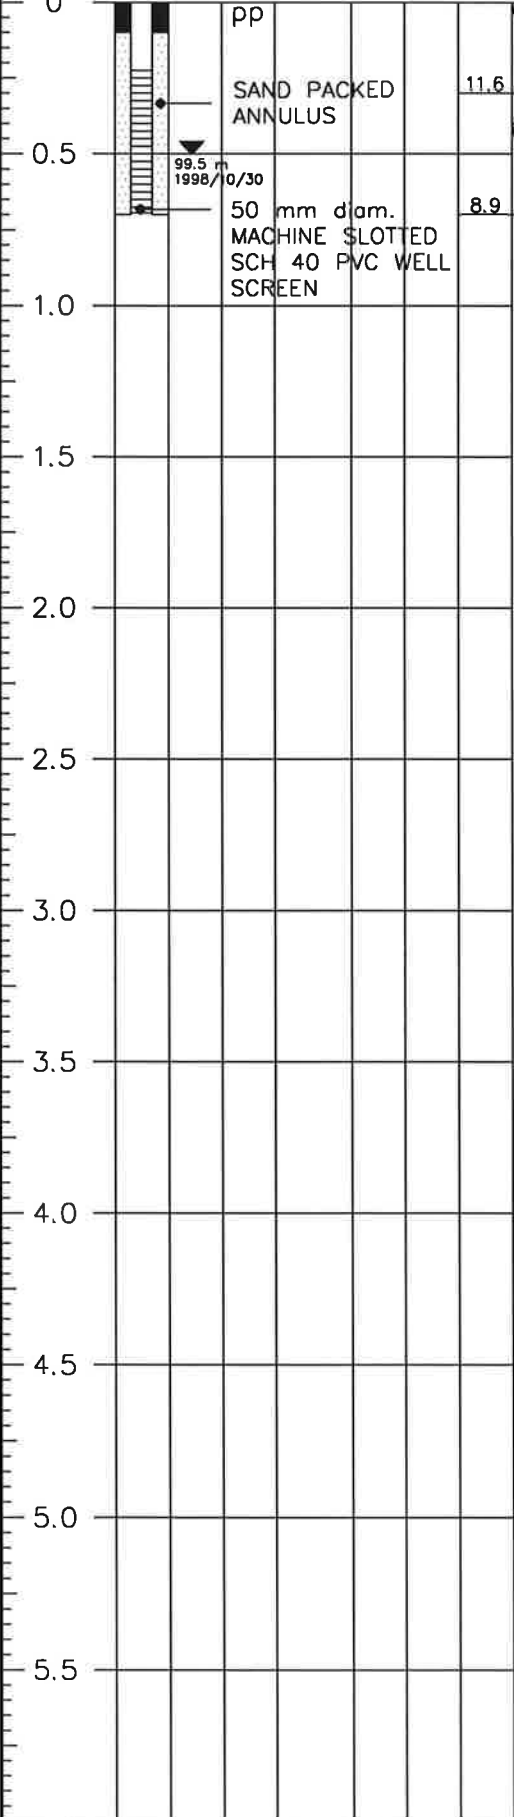
**DATE DRILLED:** OCT 9/98  
**DRAWING NUMBER:** S98-3169-3

A hydrocarbon odour was detected in the subgrade soil in Test Hole No. 98-2 in the zone 500 to 600 mm. The source of this contamination appears to be the adjacent tank bed west of the basement. Further investigation of the underground storage tanks may be required.

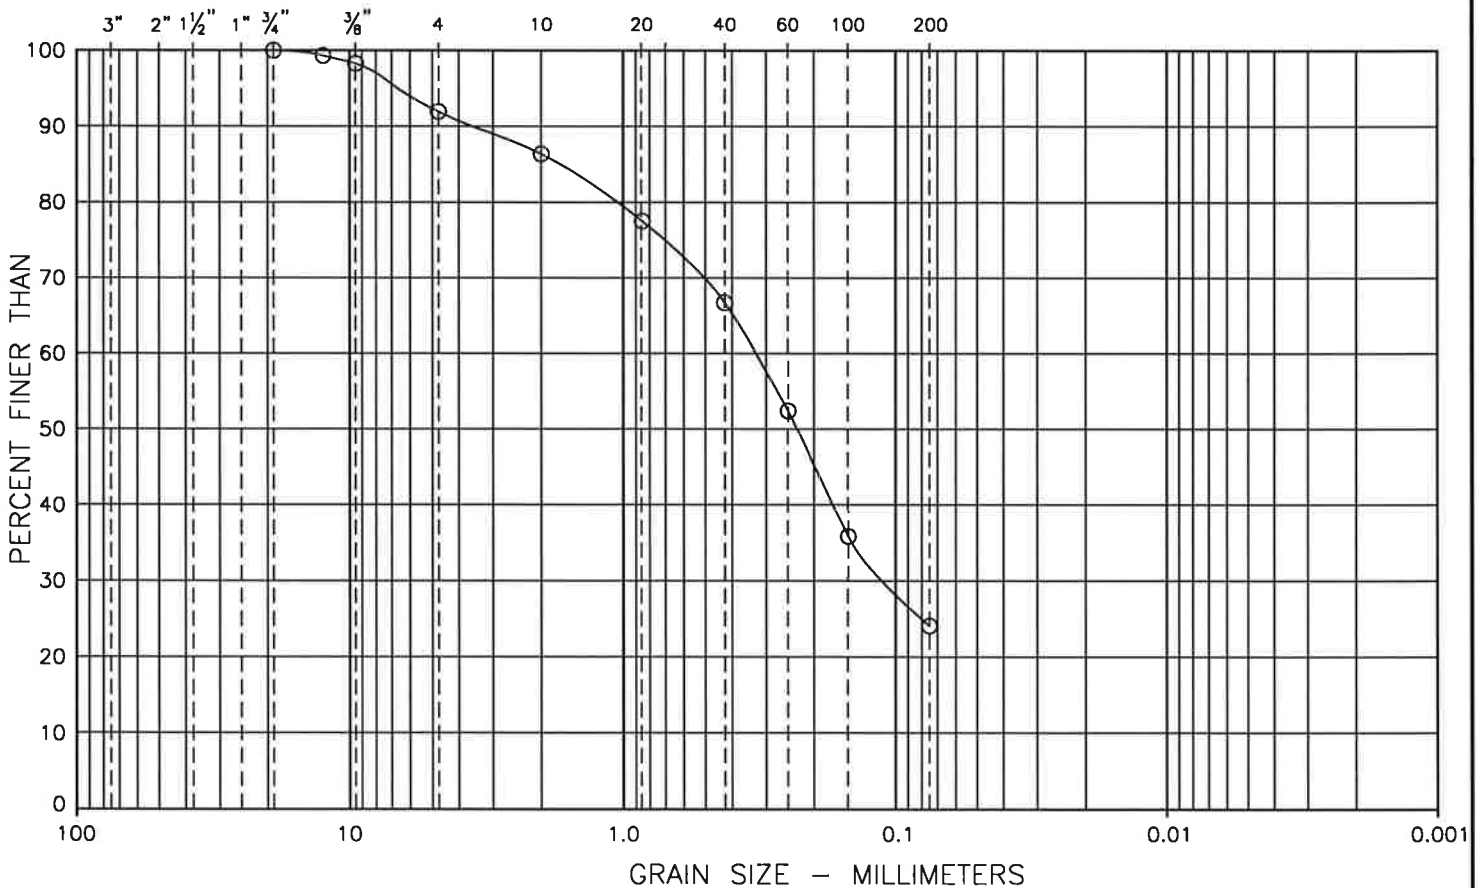
**S98-3169-4**

The soil classification and index tests performed during this investigation consisted of a visual classification of the soil, water contents and grain size distribution analysis. The results of the soil classification and index tests conducted on samples of soil have been shown plotted alongside the corresponding drill logs, opposite the depth at which soil samples were recovered, as shown on Drawing Nos. S98-3169-2 and 3. The results of the grain size distribution analyses have been shown plotted on Drawing Nos. S98-3169-4 and 5.

% Gravel Sizes	% Sand Sizes	% Silt and Clay Sizes
8	68	24

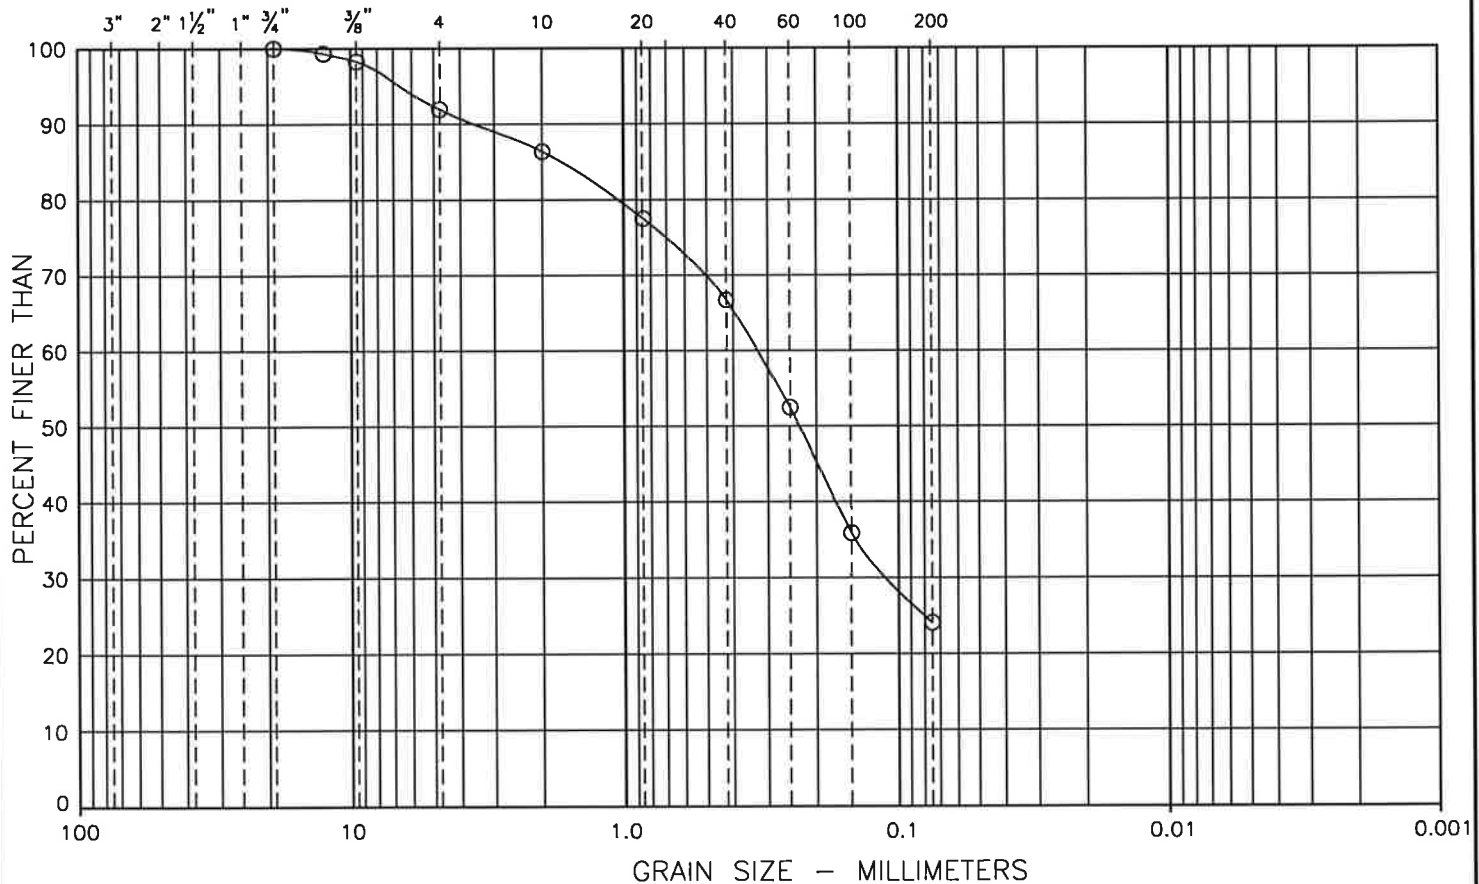
**S98-3169-5**

% Gravel Sizes	% Sand Sizes	% Silt and Clay Sizes
8	68	24
