### **PRE-RENOVATION ASSESSMENT**

**PROJECT: Access Transit – 510 46<sup>th</sup> Street – Testing of Multiple Locations for Repair**

**SUBJECT: Asbestos Site Investigation – Access Transit – Bus Storage Renovation Project.**

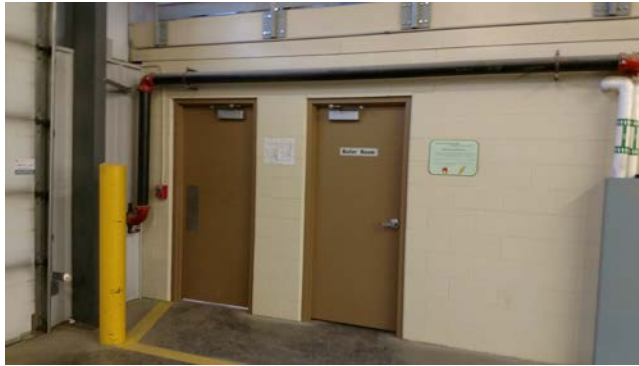
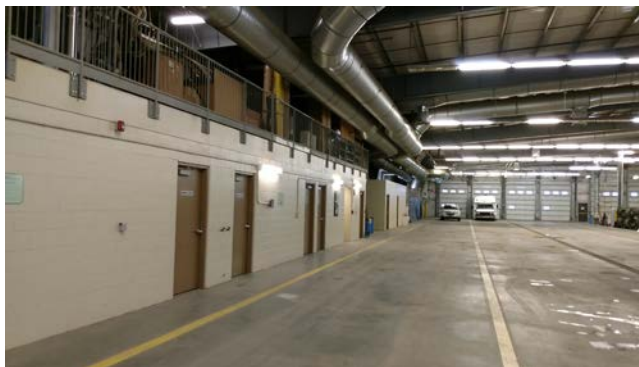
**PHOTO 1 – Cindercrete Block Wall**

The Bus Storage area of Access Transit consists of a concrete slab floor, cinder block walls (Boiler Room, Generator Room, Shower Room, etc.), drywall ceilings in Generator Room, Shower Room, etc., metal cladding walls/ceiling with plastic wrapped fiberglass batt insulation behind, metal support columns and mechanical ducting and piping insulation. Refer to the attached photos. The block walls were drilled into resulting in a hollow block cavity. No insulation was observed in the block wall.
