CITY OF SASKATOON

Asbestos-Containing Building Materials Assessment Report - Landfill Quonset Storage Building

Report Number: 1667963

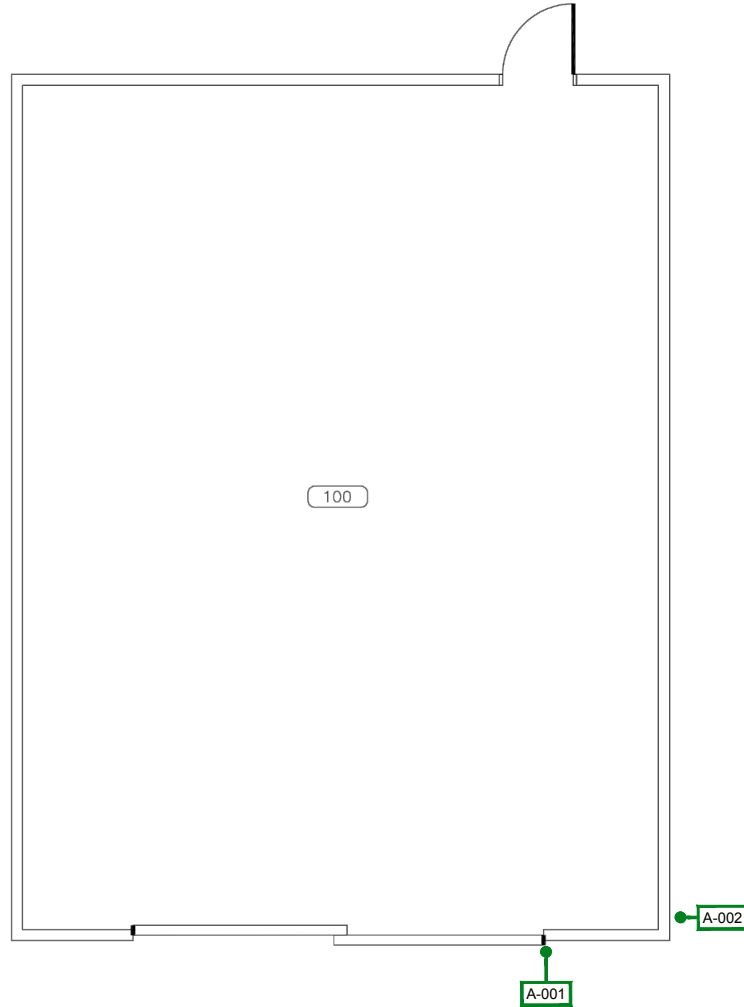
FIGURE
 1

1. ASBESTOS IS A CARCINOGEN. DO NOT BREATHE ASBESTOS DUST.
2. ASBESTOS-CONTAINING BROWN BUILDING CAULKING IS LOCATED ON THE EXTERIOR OF THE BUILDING.

MAIN FLOOR
